HISTORIC AMERICAN BUILDINGS SURVEY
INVENTORY

WO-50

2. NAME John Timmons Formhouse

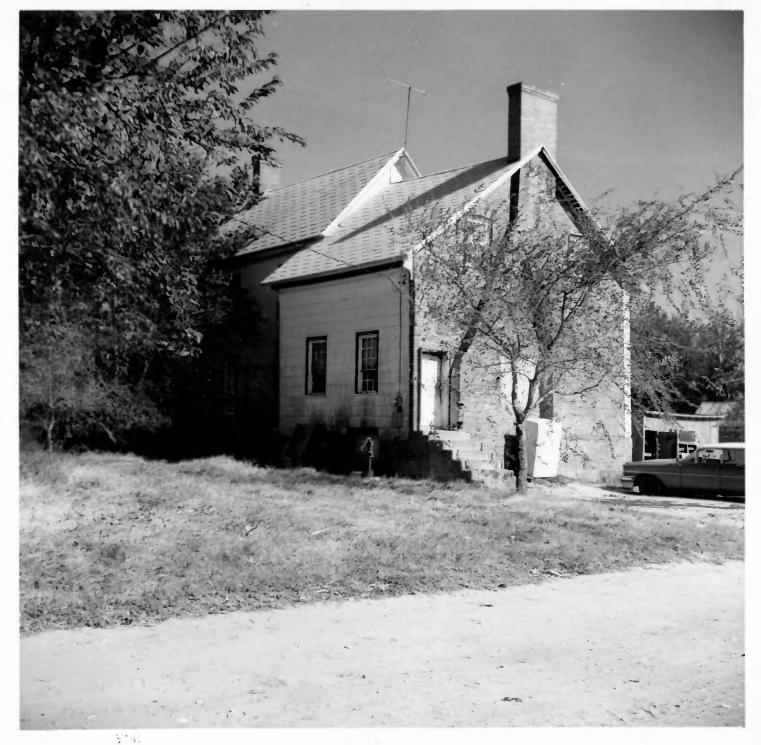
John Timmous House WO-50

The Timmons farmhouse has two parts, one is a one-story section with (knee walls), being two bays long of brick laid in common bond and having two chimneys partly projecting from the wall and joining at the 2nd story to form one chimney as it goes out the roof. The upper part is rebuilt with new brick. In the gable are two windows with six over six sash and one door on first story, access to which is by several concrete steps. The other sides of this section are built of frame covered with asbestos shingle. There are two windows with nine over six sash on each side. The original box cornice is in place as are three of the curved end-boards, typical of Worcester County houses.

On the northeast side is a two-bay wing of the late nineteenth century with four over four sash, asbestos siding.

an "A" roof and one brick chimney on its gable. It is narrower than the older section and stands about four feet taller.

It is in very poor condition and is tenanted. Two corn cribs and two other outbuildings of little interest stand near
